**MONITORING RESULTS FROM THE FIELD PILOT STUDY
OF IN SITU CAPPING OF PALOS VERDES SHELF
CONTAMINATED SEDIMENTS
(Part 2 of 2)**

July 2002

Science Applications International Corporation
Admiral's Gate
221 Third Street
Newport, RI 02840
SAIC Report Number 514

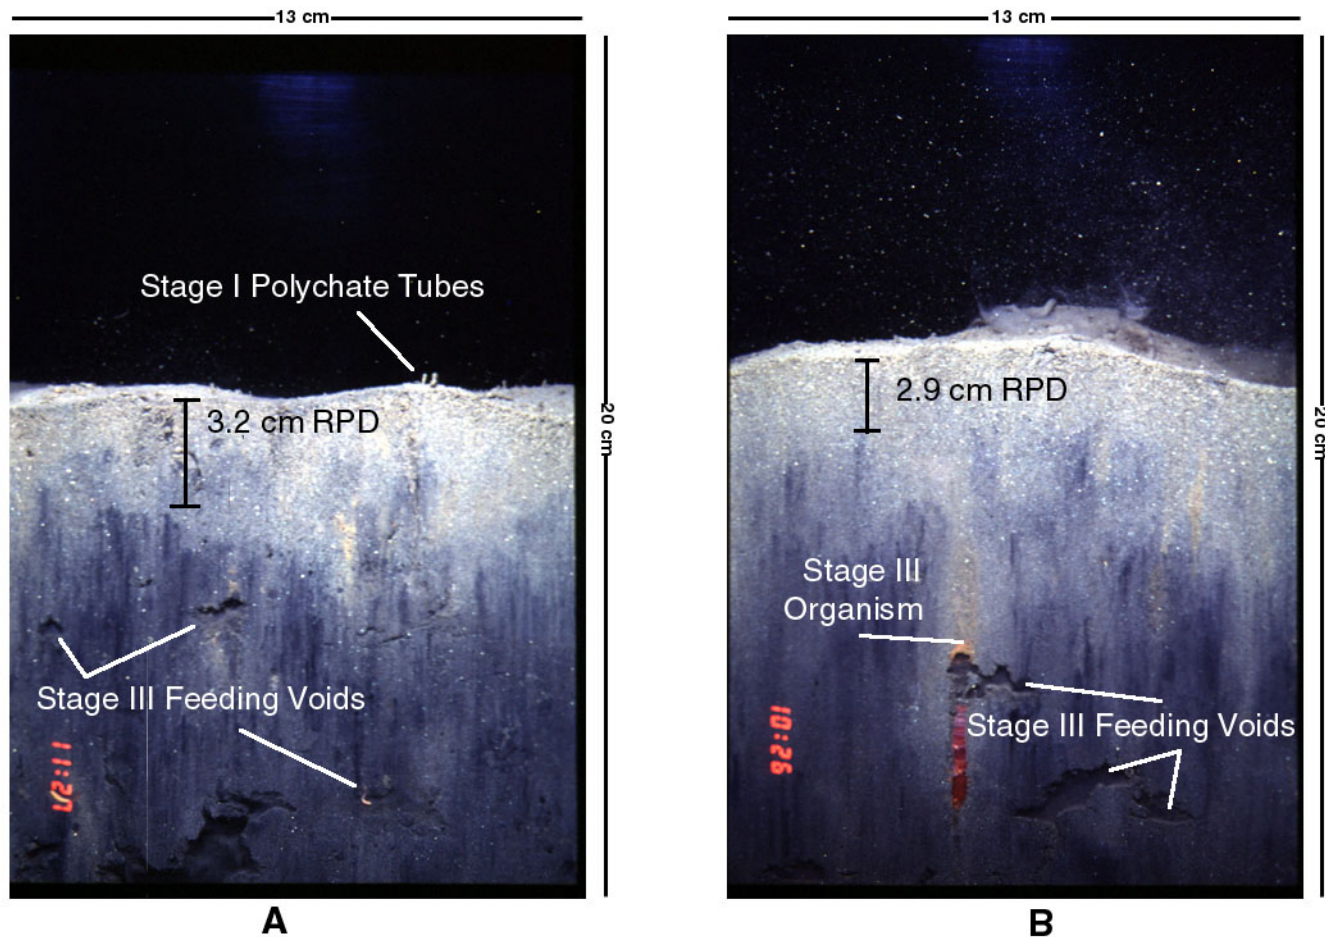
Figure 5.7-2. Sediment-profile images from Stations I05 (Image A) and I11 (Image B) illustrating typical background seafloor conditions in and around Cell LD. The sediment in both images is predominantly fine-grained (silt-clay), and its texture appears slightly coarser near the sediment surface due to an increased proportion of fine sand. Image A shows an RPD depth of 3.2 cm, Stage I polychaete tubes at the sediment surface, and Stage III feeding voids at depth (Stage I on III). The RPD depth in image B measures 2.9 cm; Stage III feeding voids and a larger-bodied Stage III organism are visible at depth in this image.

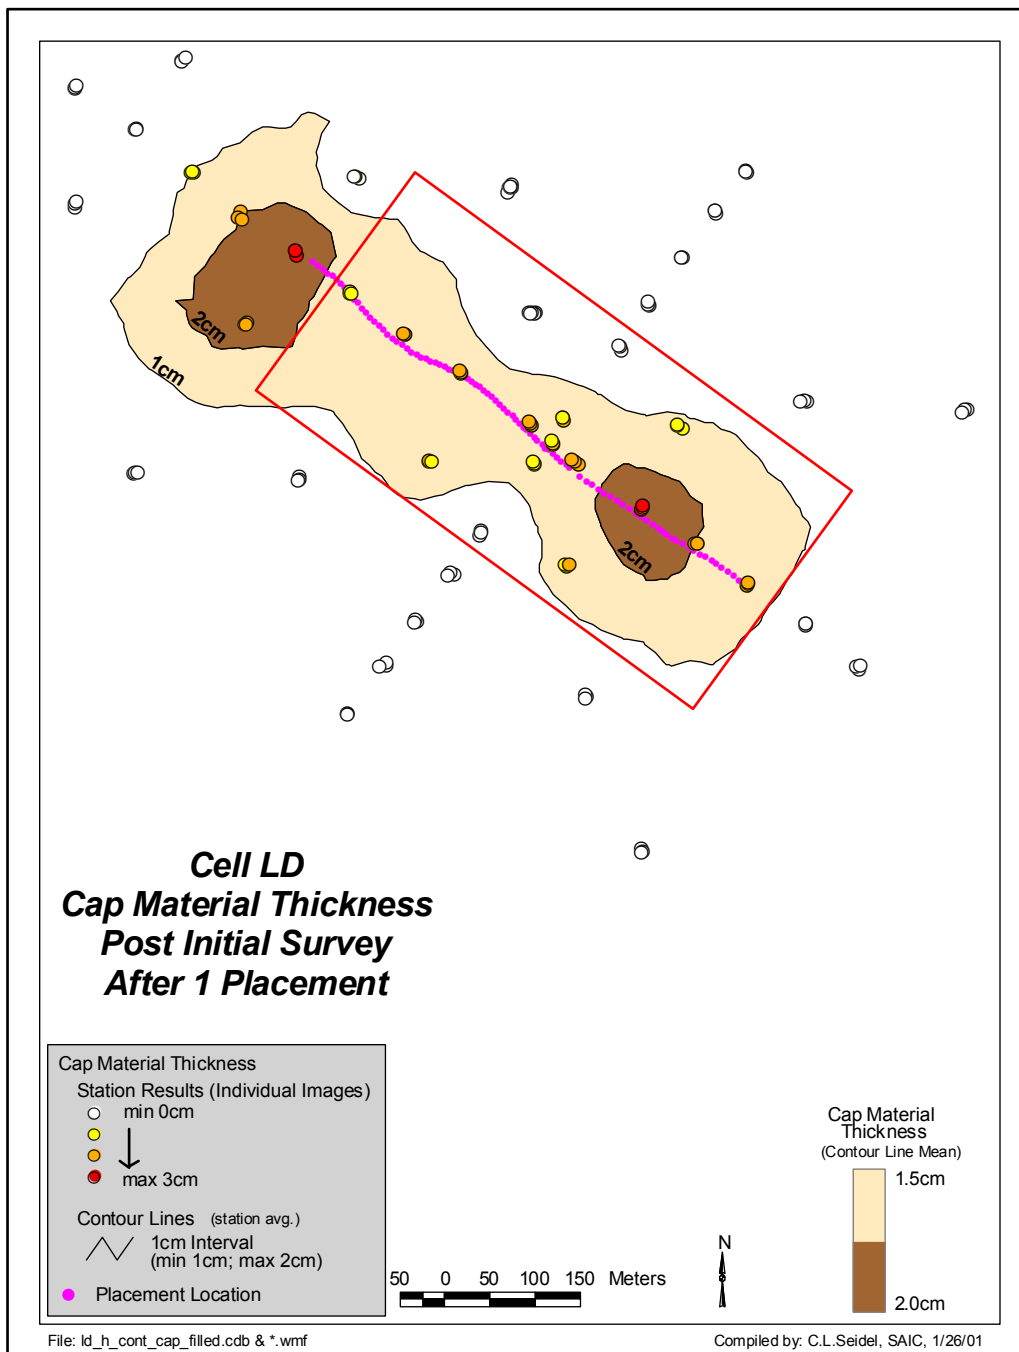
Figure 5.7-4. Track line of the hopper dredge during the first spreading placement event in Cell LD, and thickness of the resultant cap deposit on the seafloor as detected in the Post 1 SPC survey. Contour lines are based on the average measured thickness of the cap material layer at each station (mean of $n = 3$ replicate sediment profile images), while each plotted circle depicts the cap material thickness measurement for an individual replicate image.

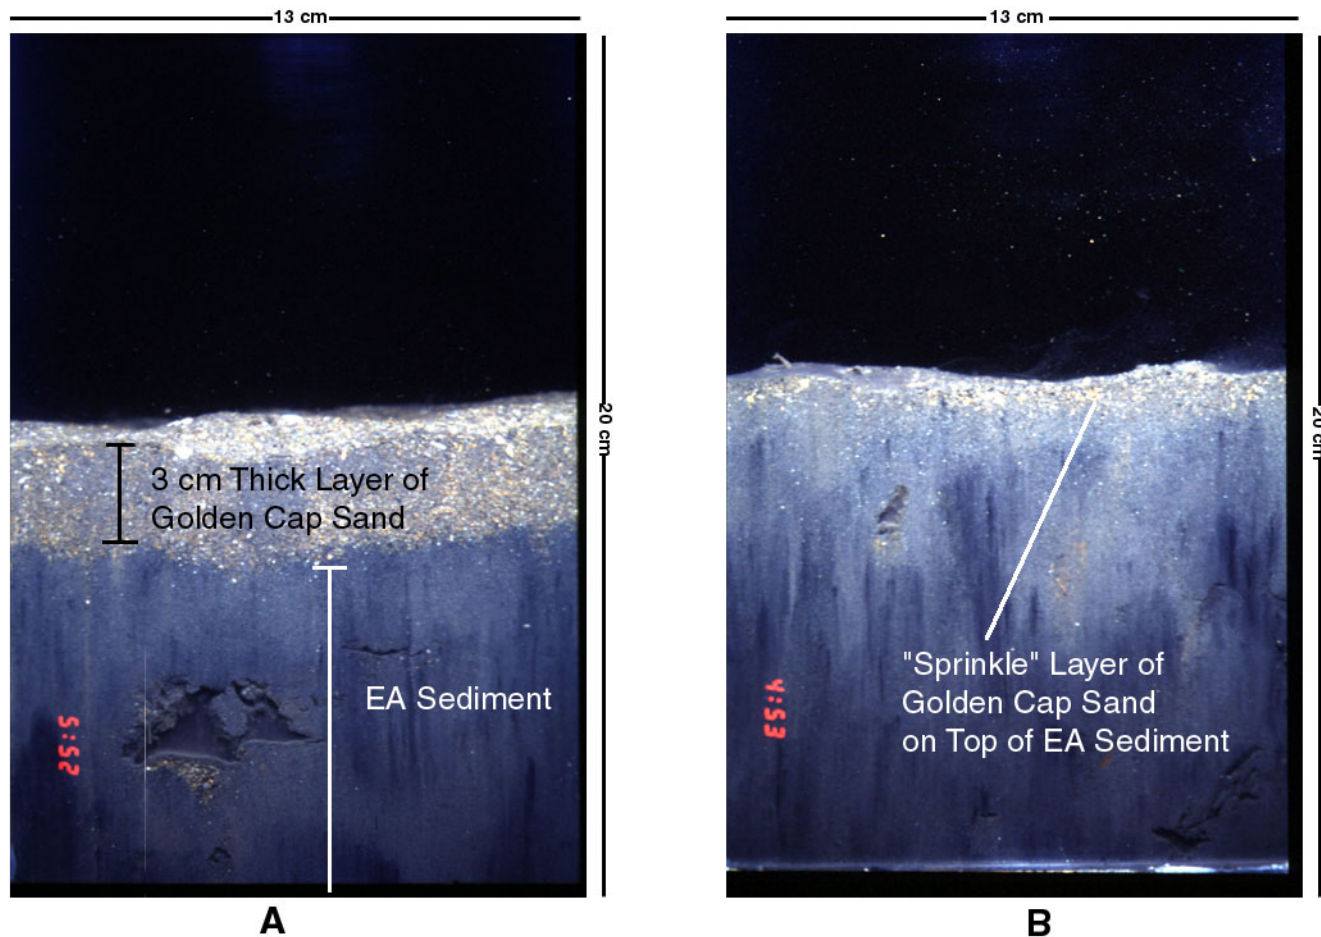
Figure 5.7-5. Sediment profile images from the Post-1 survey in Cell LD illustrating variations in the thickness of the cap material layer. Image A from station O09 shows a continuous, 3-cm thick depositional layer of the homogenous, golden fine sand cap sand from A-III Borrow Area overlying the fine-grained EA sediment at depth. Image B from station I08 provides an example of a thin and patchy “sprinkle” layer of cap material deposited at the surface of the EA sediment. The measured thickness of such sprinkle layers was generally less than 1 cm.

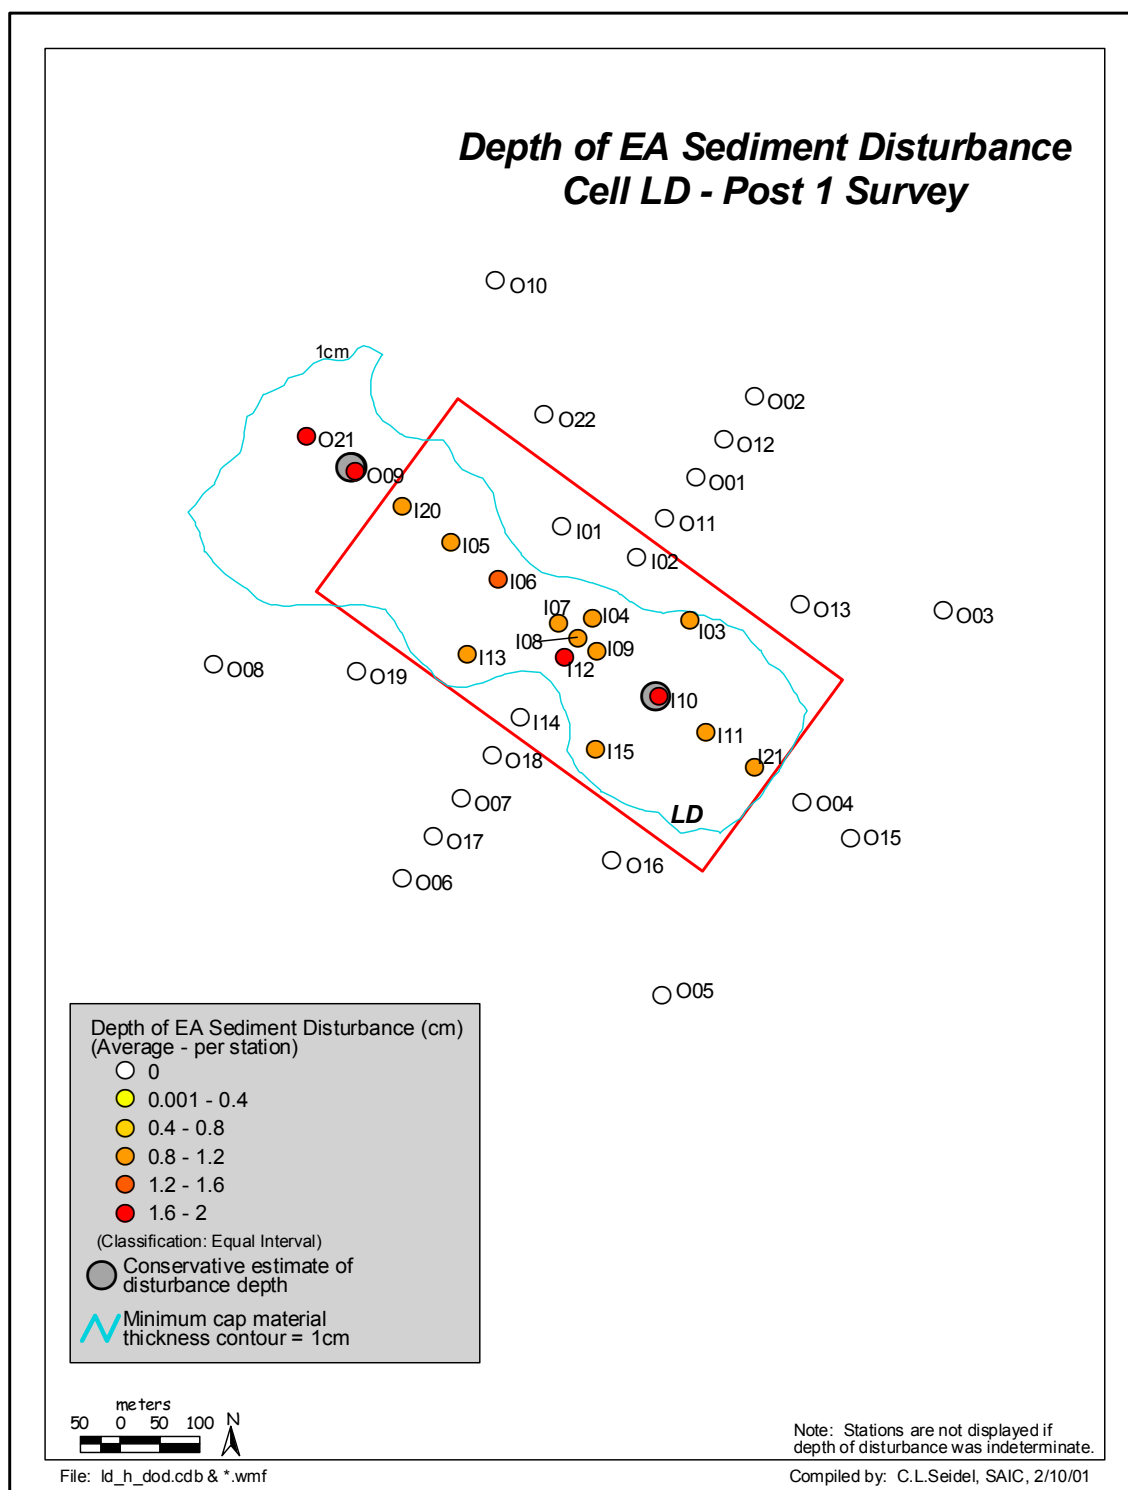
Figure 5.7-7. Estimated depth of disturbance of EA sediment for the Post 1 SPC survey in Cell LD.

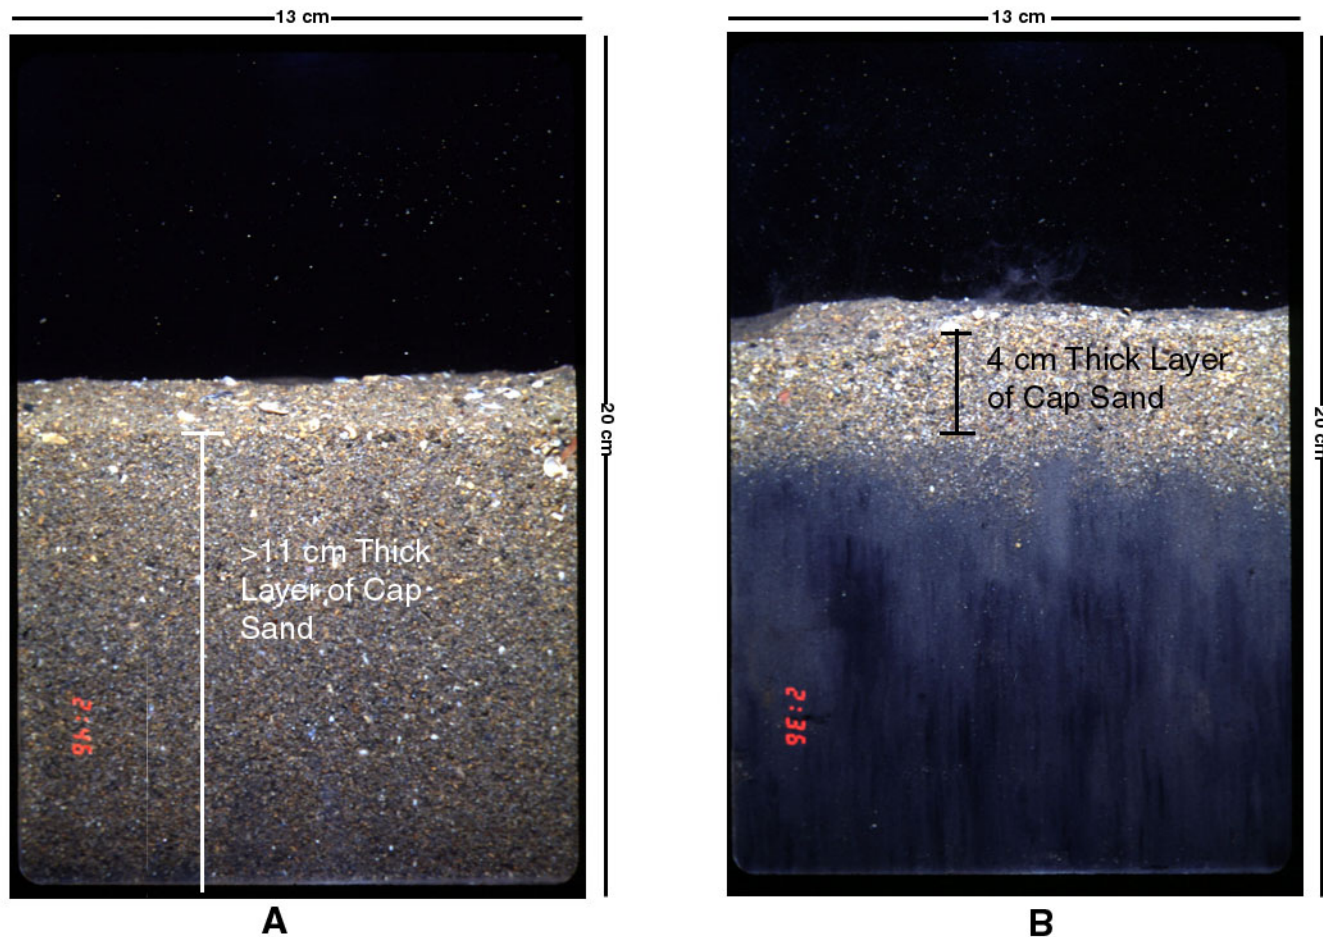
Figure 5.7-9. Representative sediment profile images from the Post-9 survey in Cell LD. Image A from station I06 shows the cap material from A-III Borrow Area (homogenous, golden sand) extending from the sediment surface to below the imaging depth (cap material thickness greater than the penetration depth of 11 cm). Image B from station I20 shows a discrete layer of the golden cap sand measuring 4 cm thick.

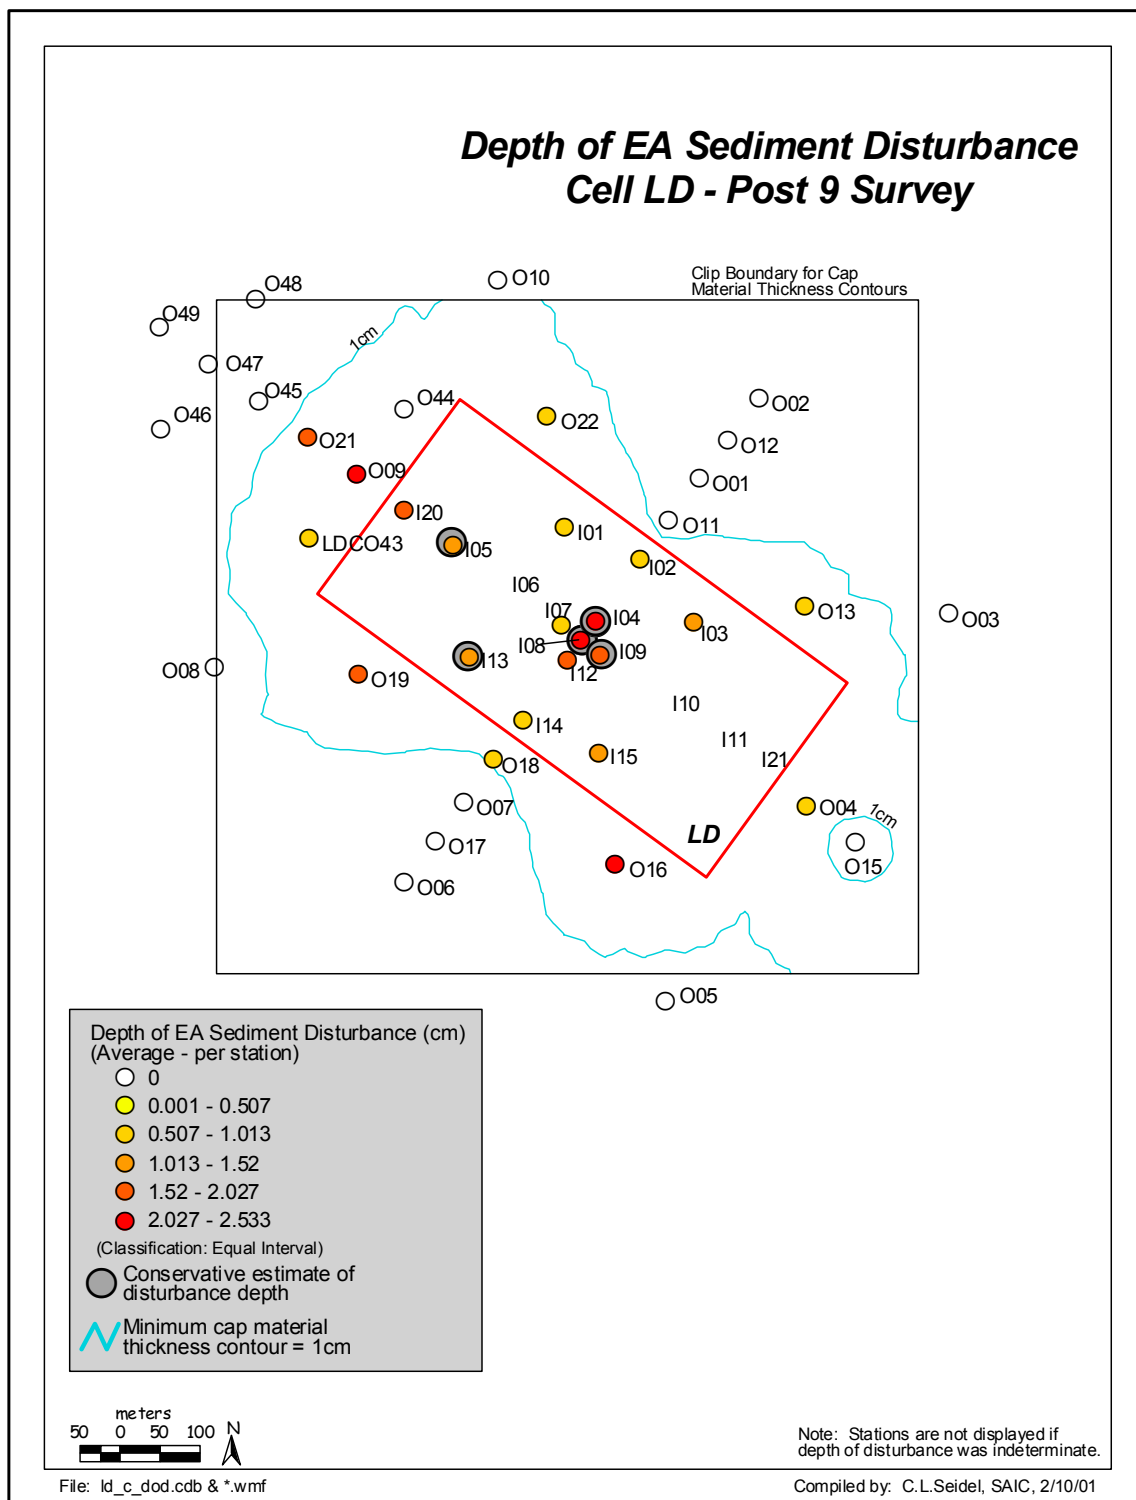
Figure 5.7-11. Estimated depth of disturbance of EA sediment for the Post 9 SPC survey in Cell LD.

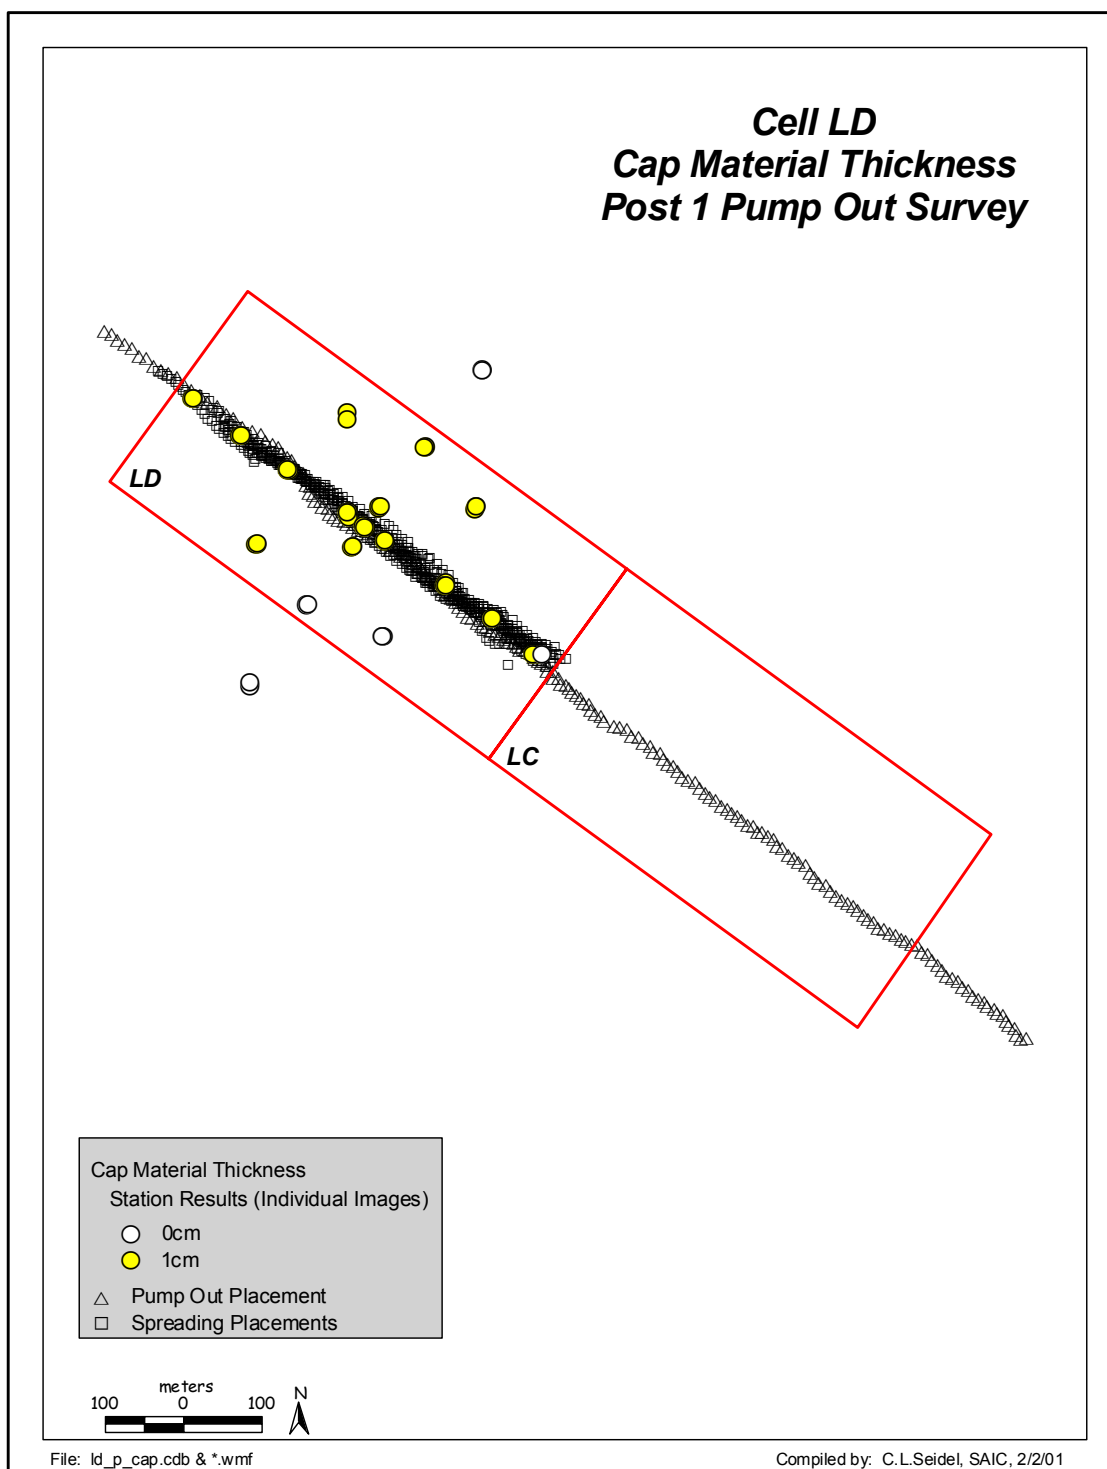
Figure 5.7-13. Track line of the hopper dredge during pump-out placement in Cell LD, and thickness of the resultant cap layer in replicate images obtained at each station.

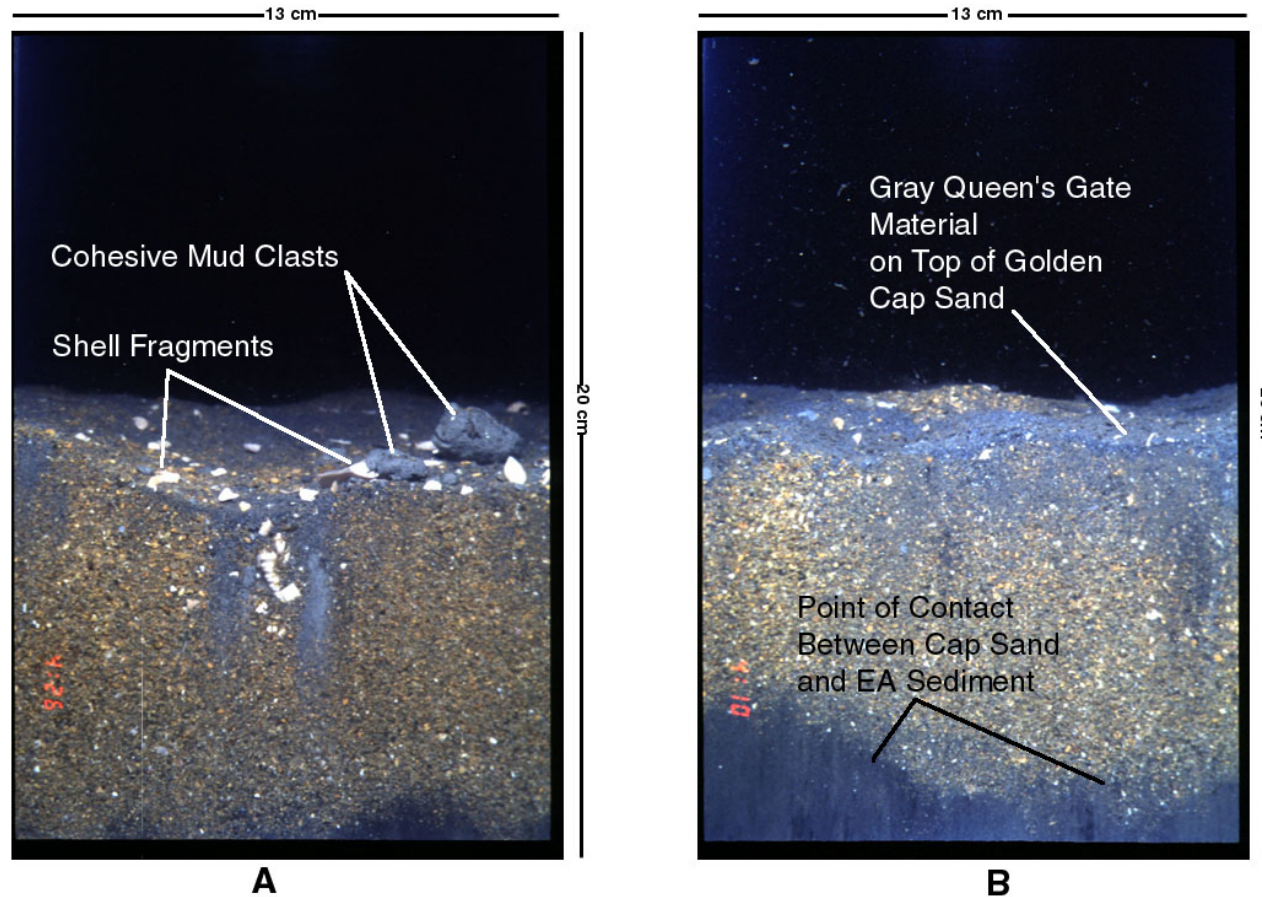
Figure 5.7-14. Two representative sediment profile images from the post pump-out survey in Cell LD. Image A from station I06 shows a very thin and patchy “sprinkle” layer of gray-colored Queen’s Gate cap material on top of the golden cap sand from A-III Borrow Area. Note that the gray Queen’s Gate material includes numerous shell fragments and cohesive mud clasts in this image. Image B from station I09 likewise shows a thin and patchy depositional layer of gray Queen’s Gate material at the surface of the golden cap sand. The point of contact between the layer of golden cap sand and the underlying EA sediment also is visible in this image. In both images, the thickness of the surface depositional layer of gray Queen’s Gate cap material was estimated to be less than 1 cm.

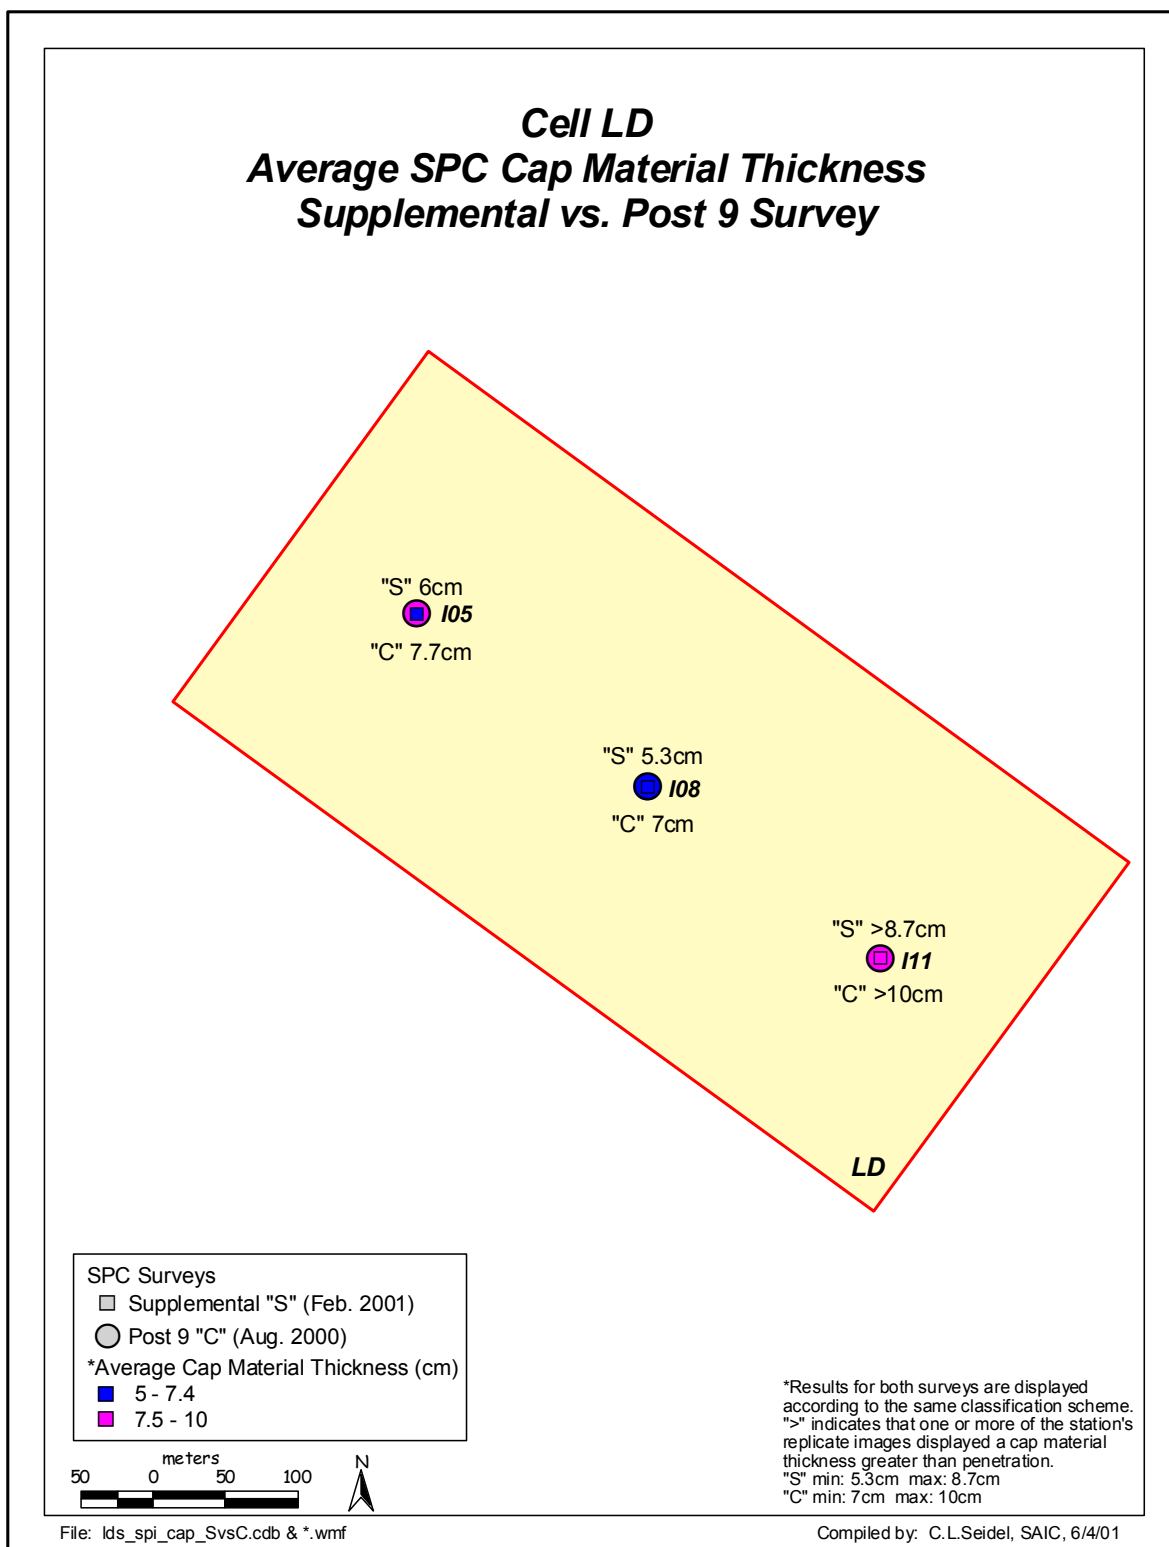
Figure 5.7-16. Average thickness of the cap material layer observed at each station in the August 2000 Post-9 survey and the February 2001 supplemental survey.

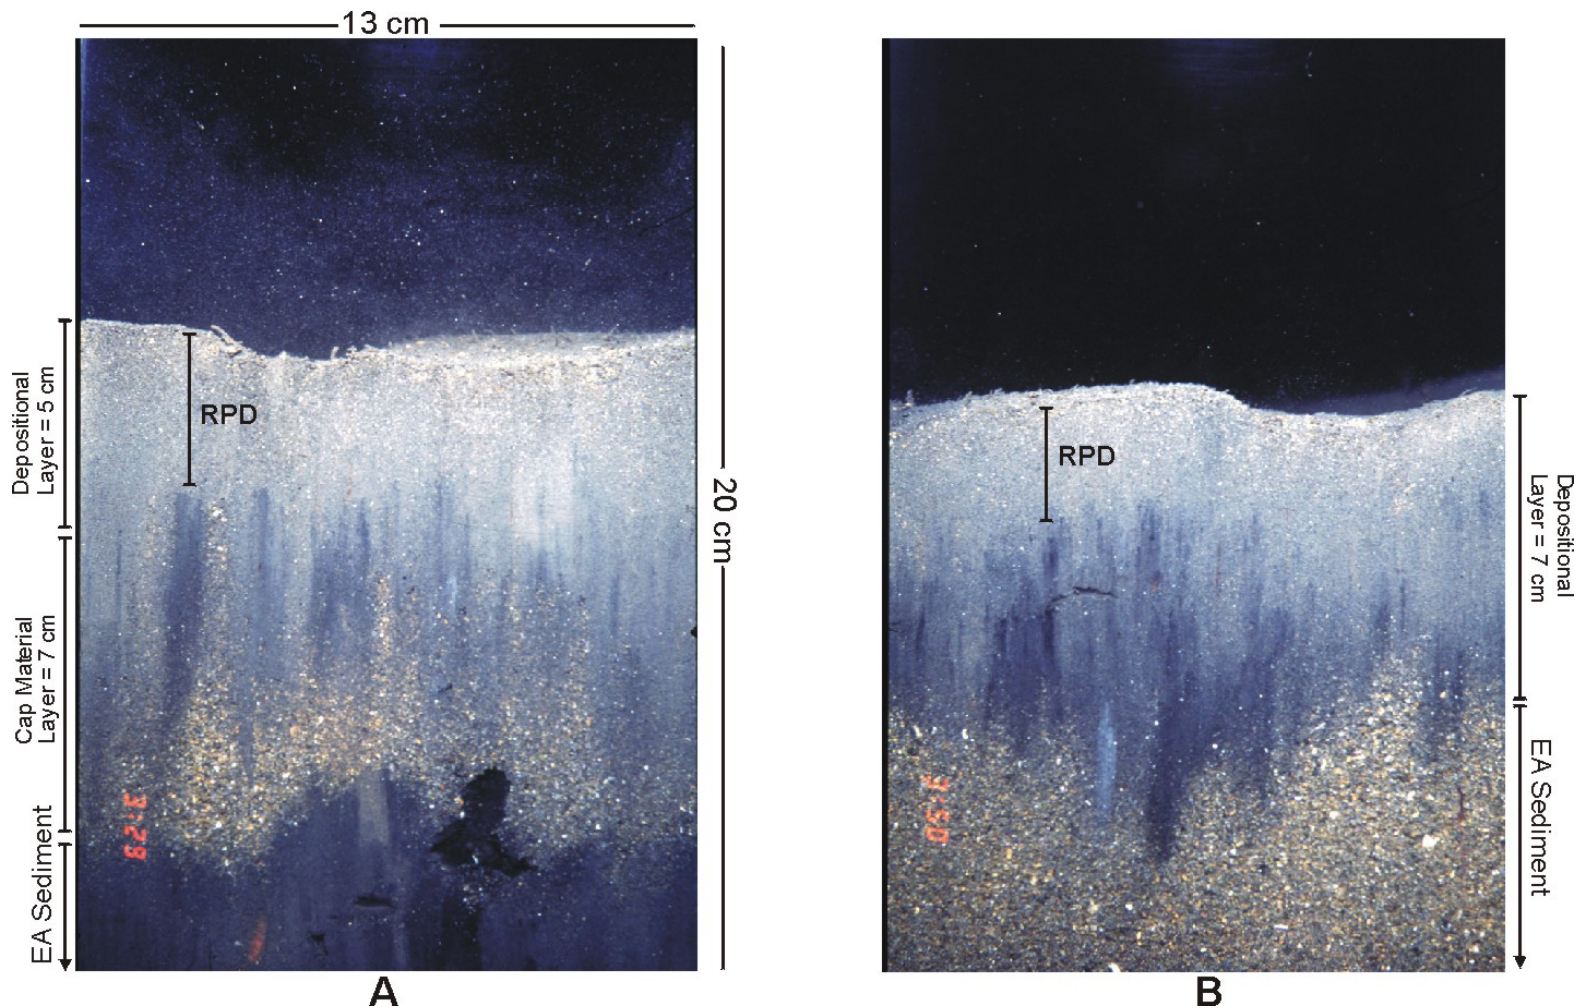
Figure 5.7-17. Sediment profile images obtained in the supplemental survey at Cell LD stations I05 (image A) and I11 (image B). Image A shows a 5-cm surface depositional layer of fine-grained sediment overlying a 7-cm layer of golden sand (cap material from A-III Borrow Area). The golden sand cap material layer in turn overlies EA sediment at depth. In image B, a 7-cm surface depositional layer of fine-grained sediment overlies a cap material layer (golden sand) that extends below the imaging depth of the sediment profile camera (>6 cm thickness). In both images, the new surface depositional layer of fine-grained sediment is beginning to develop an RPD.

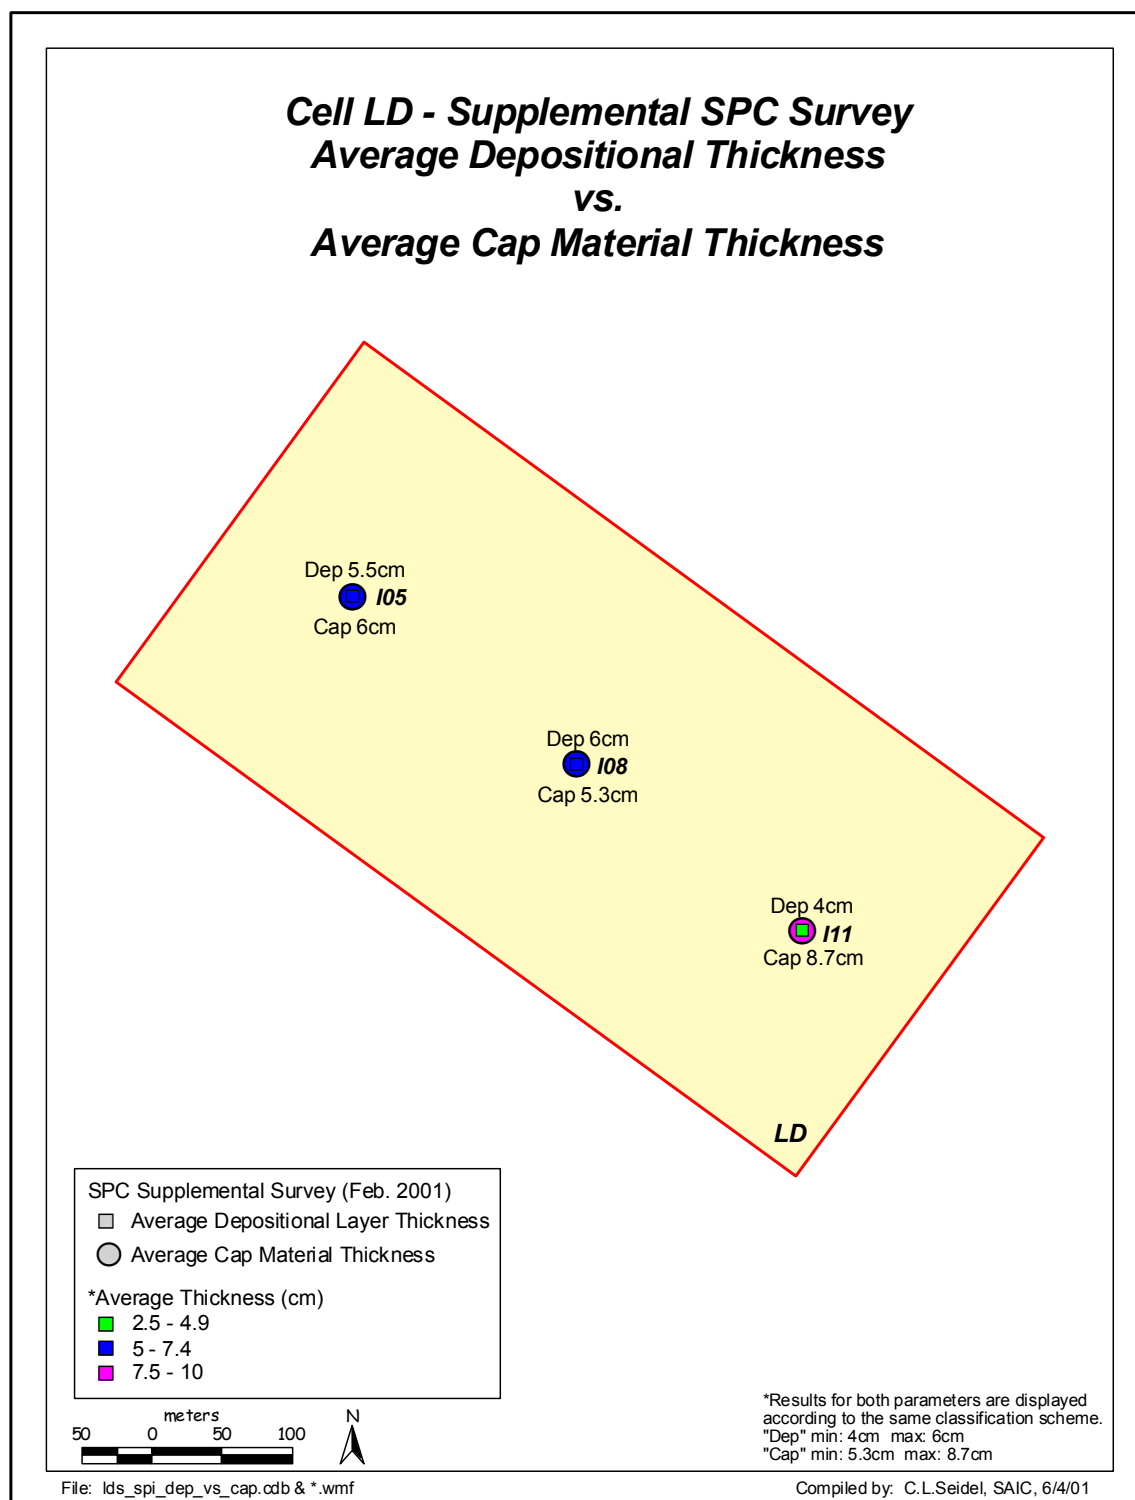
Figure 5.7-18. Map showing the average thickness of both the surface depositional layer of fine-grained sediment and the underlying cap material layer at each station in the February 2001 supplemental survey.

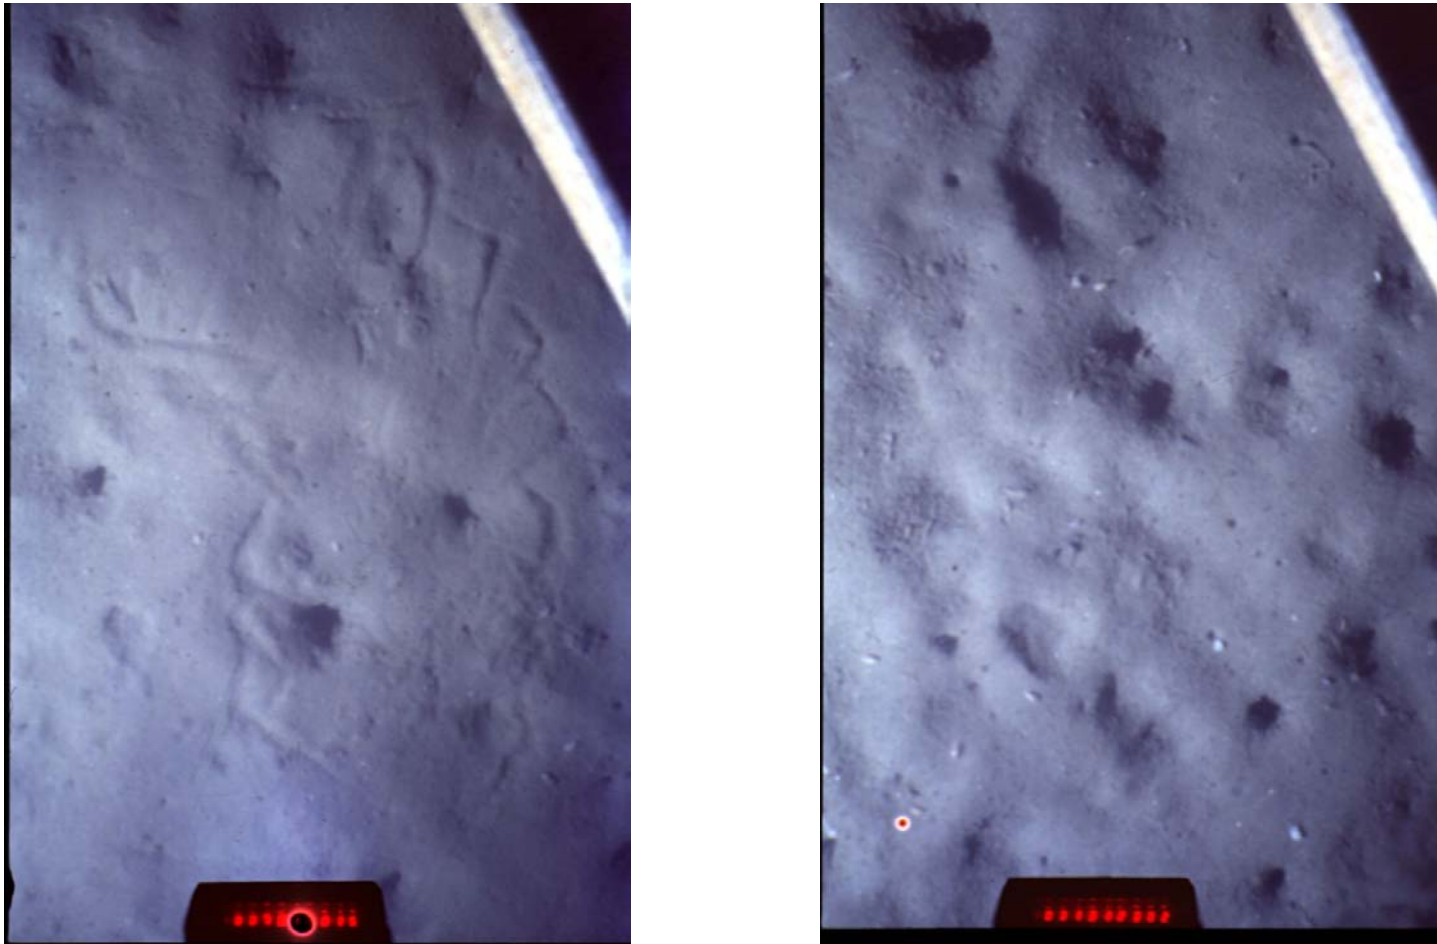
Figure 5.8-2. Biological burrows. These images taken during the baseline survey in Cell LD Stations I07 and I09 typifies the type and amounts of biological burrows found on the Palos Verdes Shelf prior to cap placement.

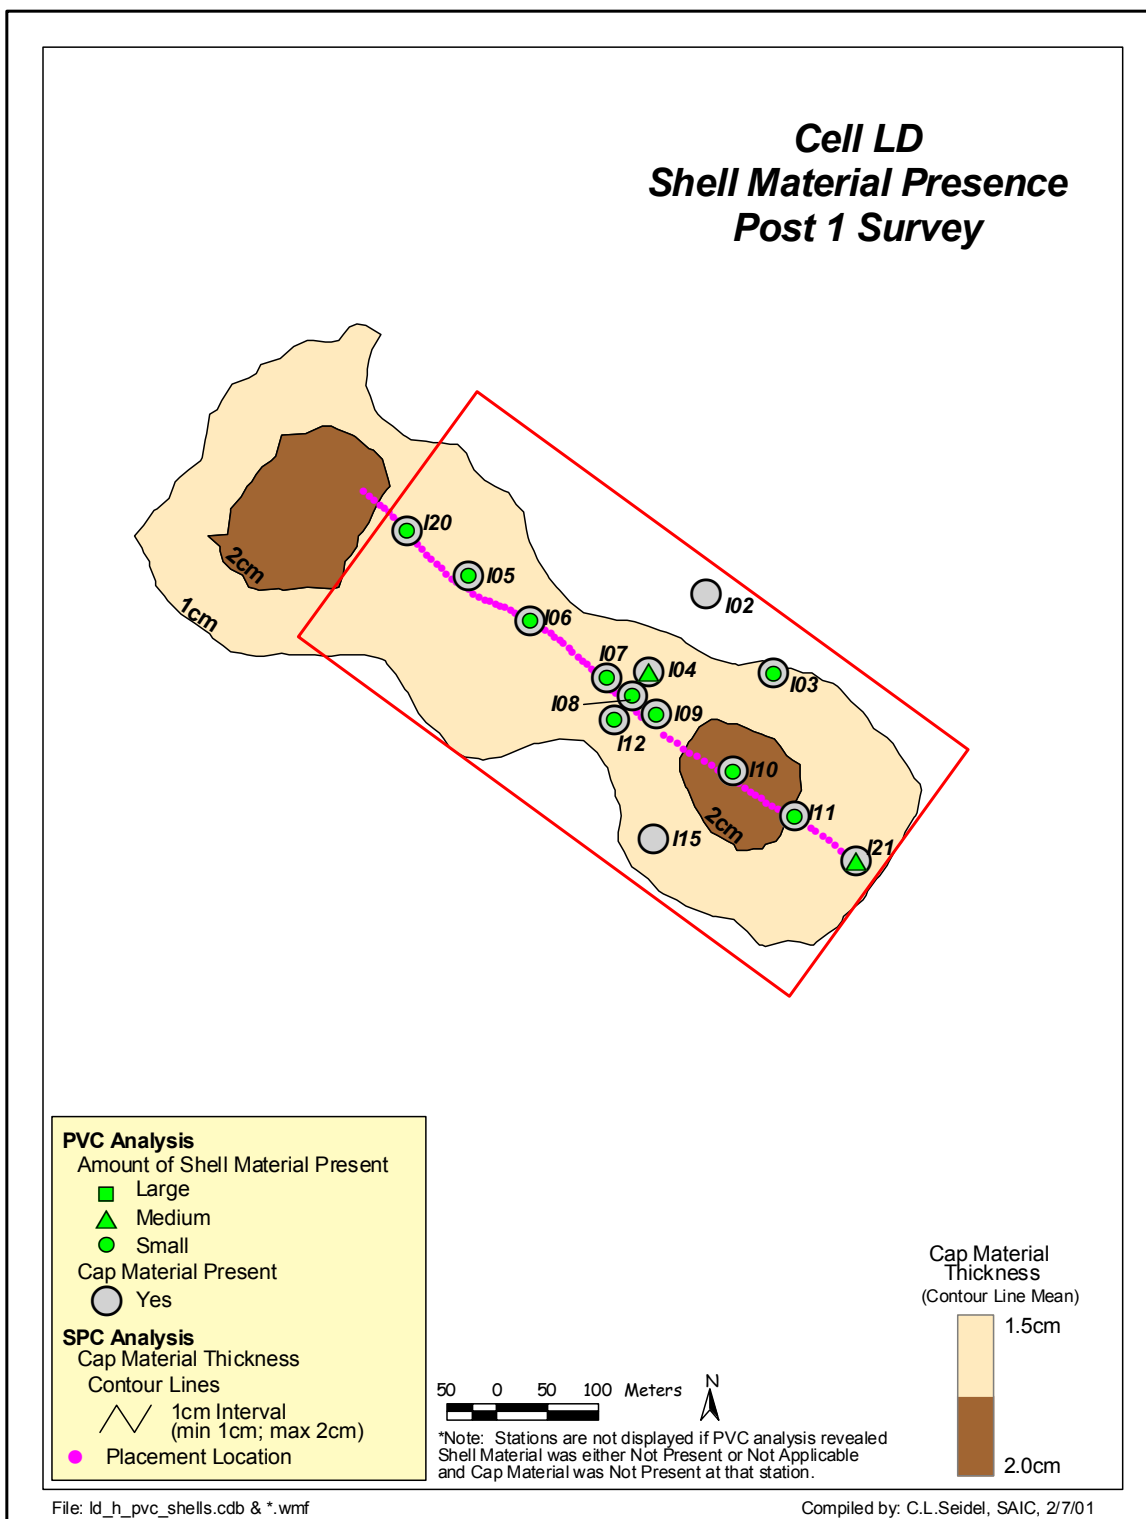
Figure 5.8-4. Lateral extent of cap material based on planview image (PVI) analysis – Post 1 survey. The plan view image data are overlain on the SPI cap material footprint.

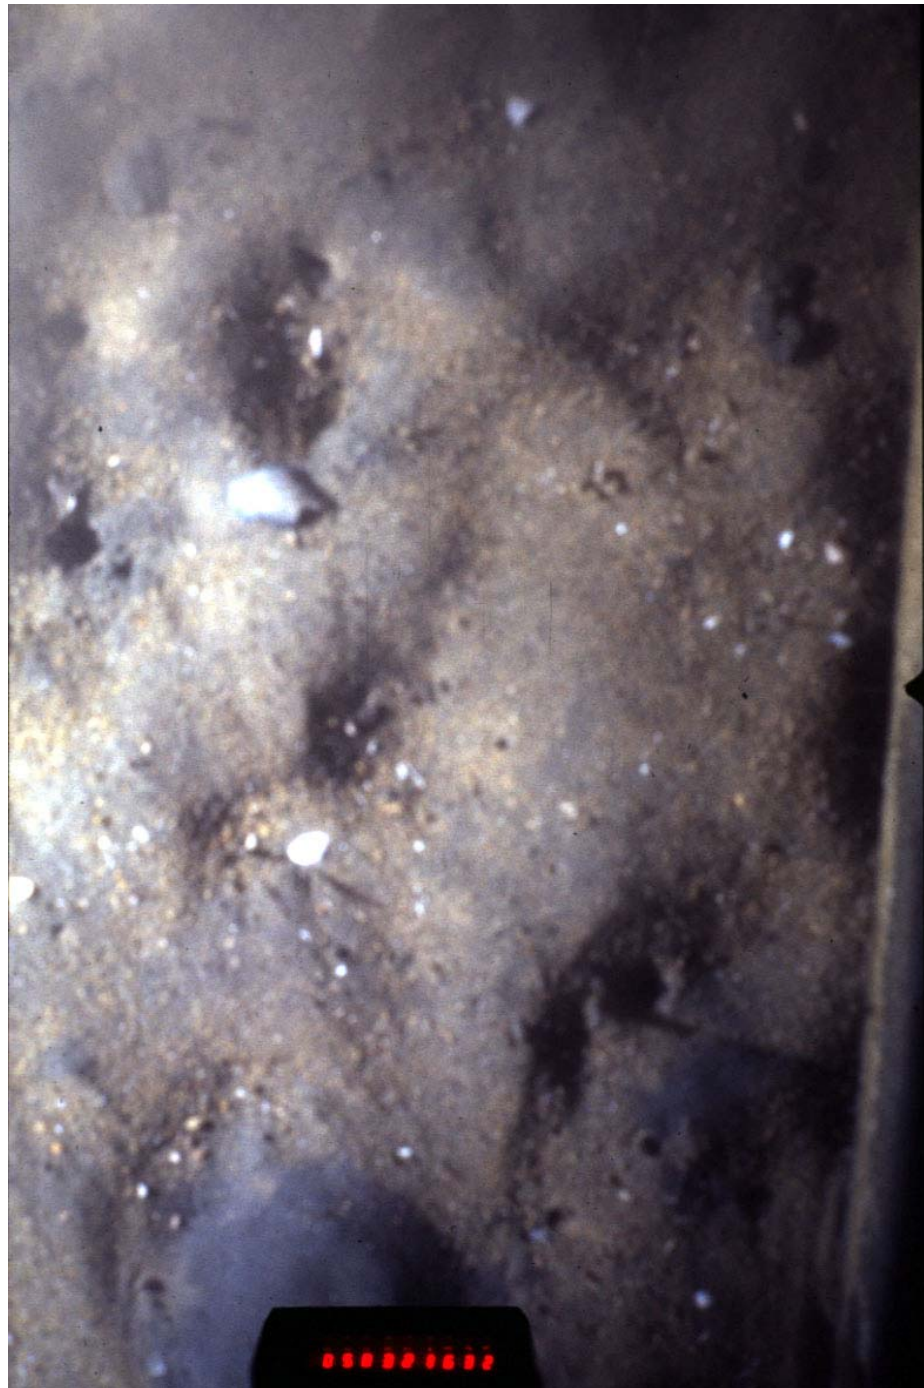
Figure 5.8-5. Color Contrast of Cap Material and EA Sediments. This plan view image acquired at inside station I10 in Cell LD provides an example of the color differences between the golden borrow cap material and the gray ambient sediments. This color difference aided in the identification of the presence or absence of cap material during analysis, even in areas where cap material was present in only trace (patchy) amounts.
